# Submerged Cultural Resources Inventory

PORTIONS OF  
POINT REYES NATIONAL SEASHORE  
and  
POINT REYES-FARALLON ISLANDS  
NATIONAL MARINE SANCTUARY

Field Research Results

Session 1  
1983

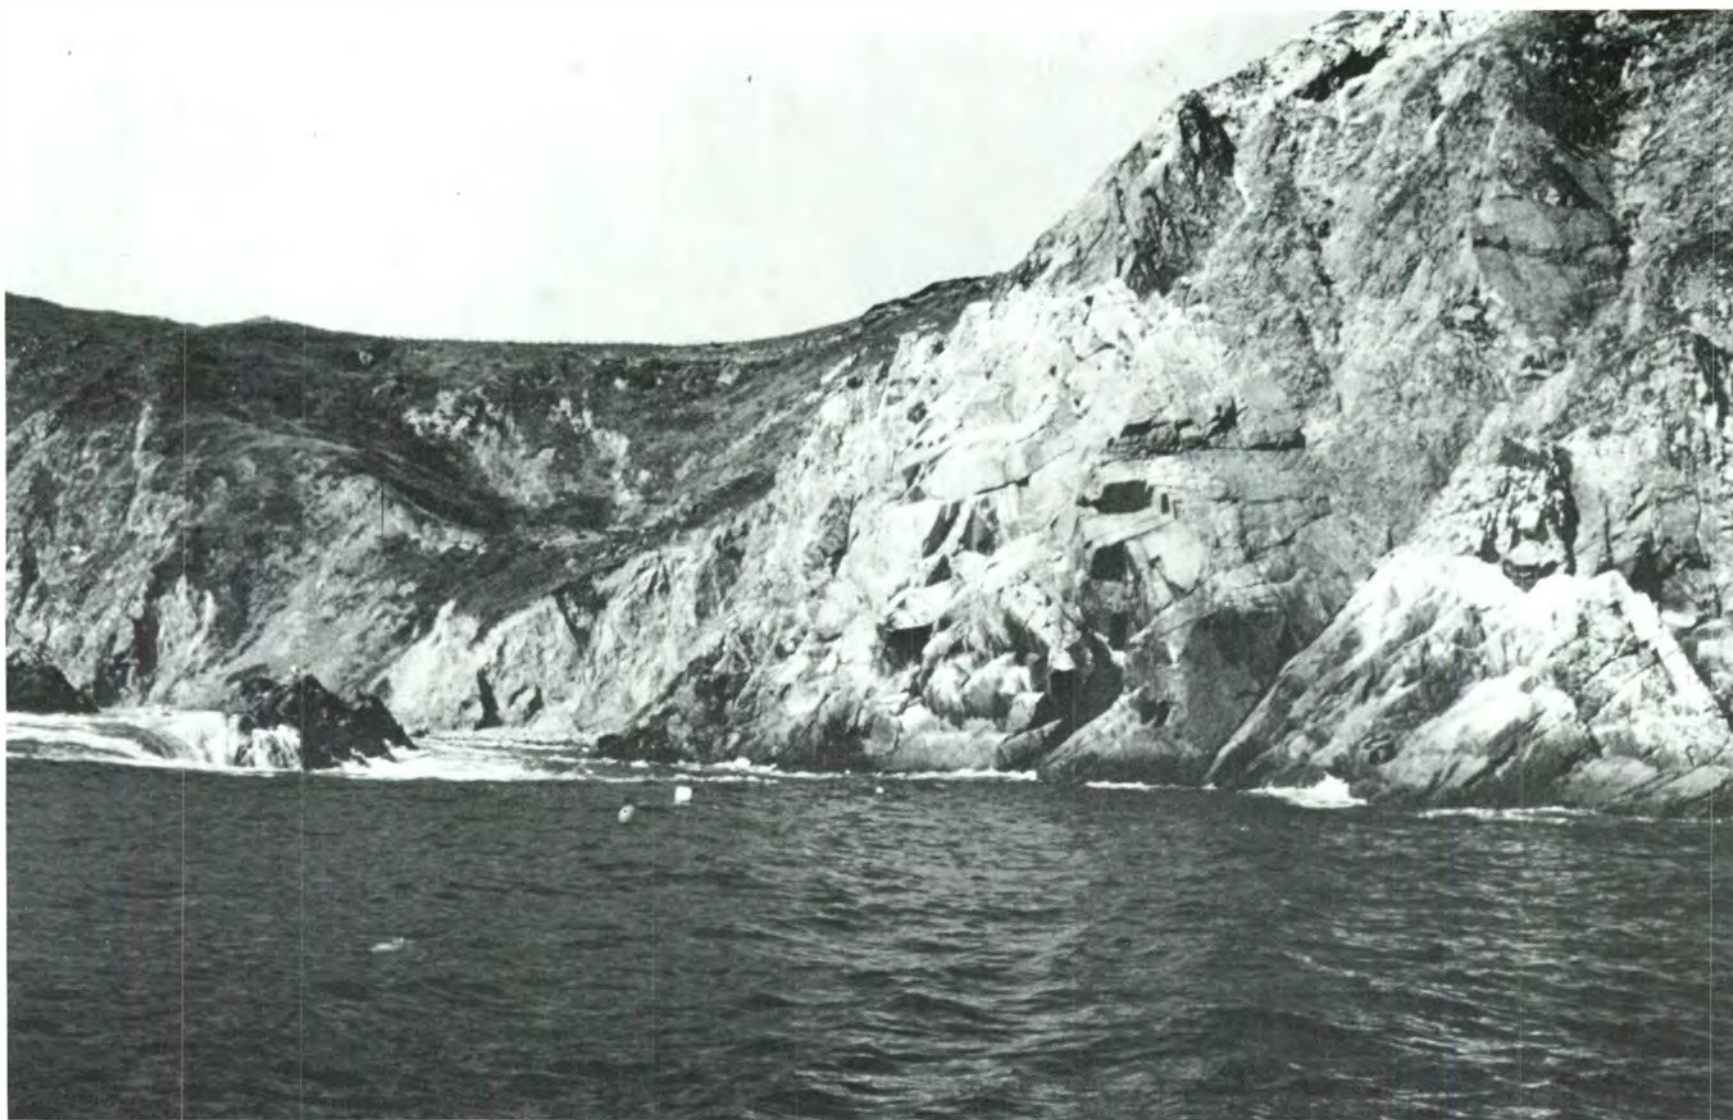
Figure 6. Sail Rock (right) and another smaller outcropping (left) mark the boundaries of the shallow gully where MUNLEON rests. The three buoys (center) indicate the locations of the engine, port and starboard boilers.

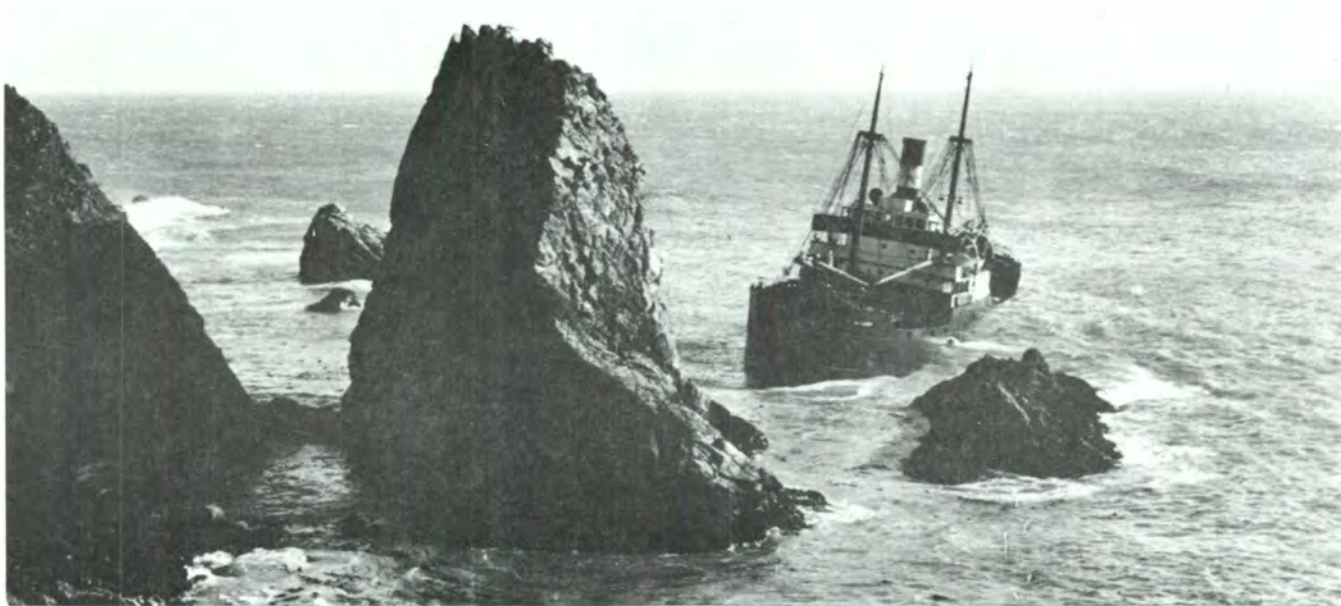
Figure 8. MUNLEON ran aground in a dense fog nearly ramming into Sail Rock. The proximity of the vessel to Sail Rock and general orientation of the wreckage, even as it exists today, is clearly shown by this 1931 photo of the grounded vessel. Photo courtesy of National Maritime Museum, San Francisco.

The arrangement of the various components gives the impression of a vessel which finally settled listing to port; photographs of the stranded vessel confirm this interpretation (Figure 8). As wave action and surge ground the bow on shallow rocks, the vessel began the normal wrecking processes by breaking apart along lines of structural weakness, in this case at the turn of the bilge. However, apparent discrepancies were observed in the relationships of vessel components, in the deposition of a great quantity of materials to starboard and in the fact that a large portion of the vessel cannot be accounted for. Together, these suggest that intervention in the normal wrecking process occurred; one plausible explanation for the discrepancies is salvage operations.

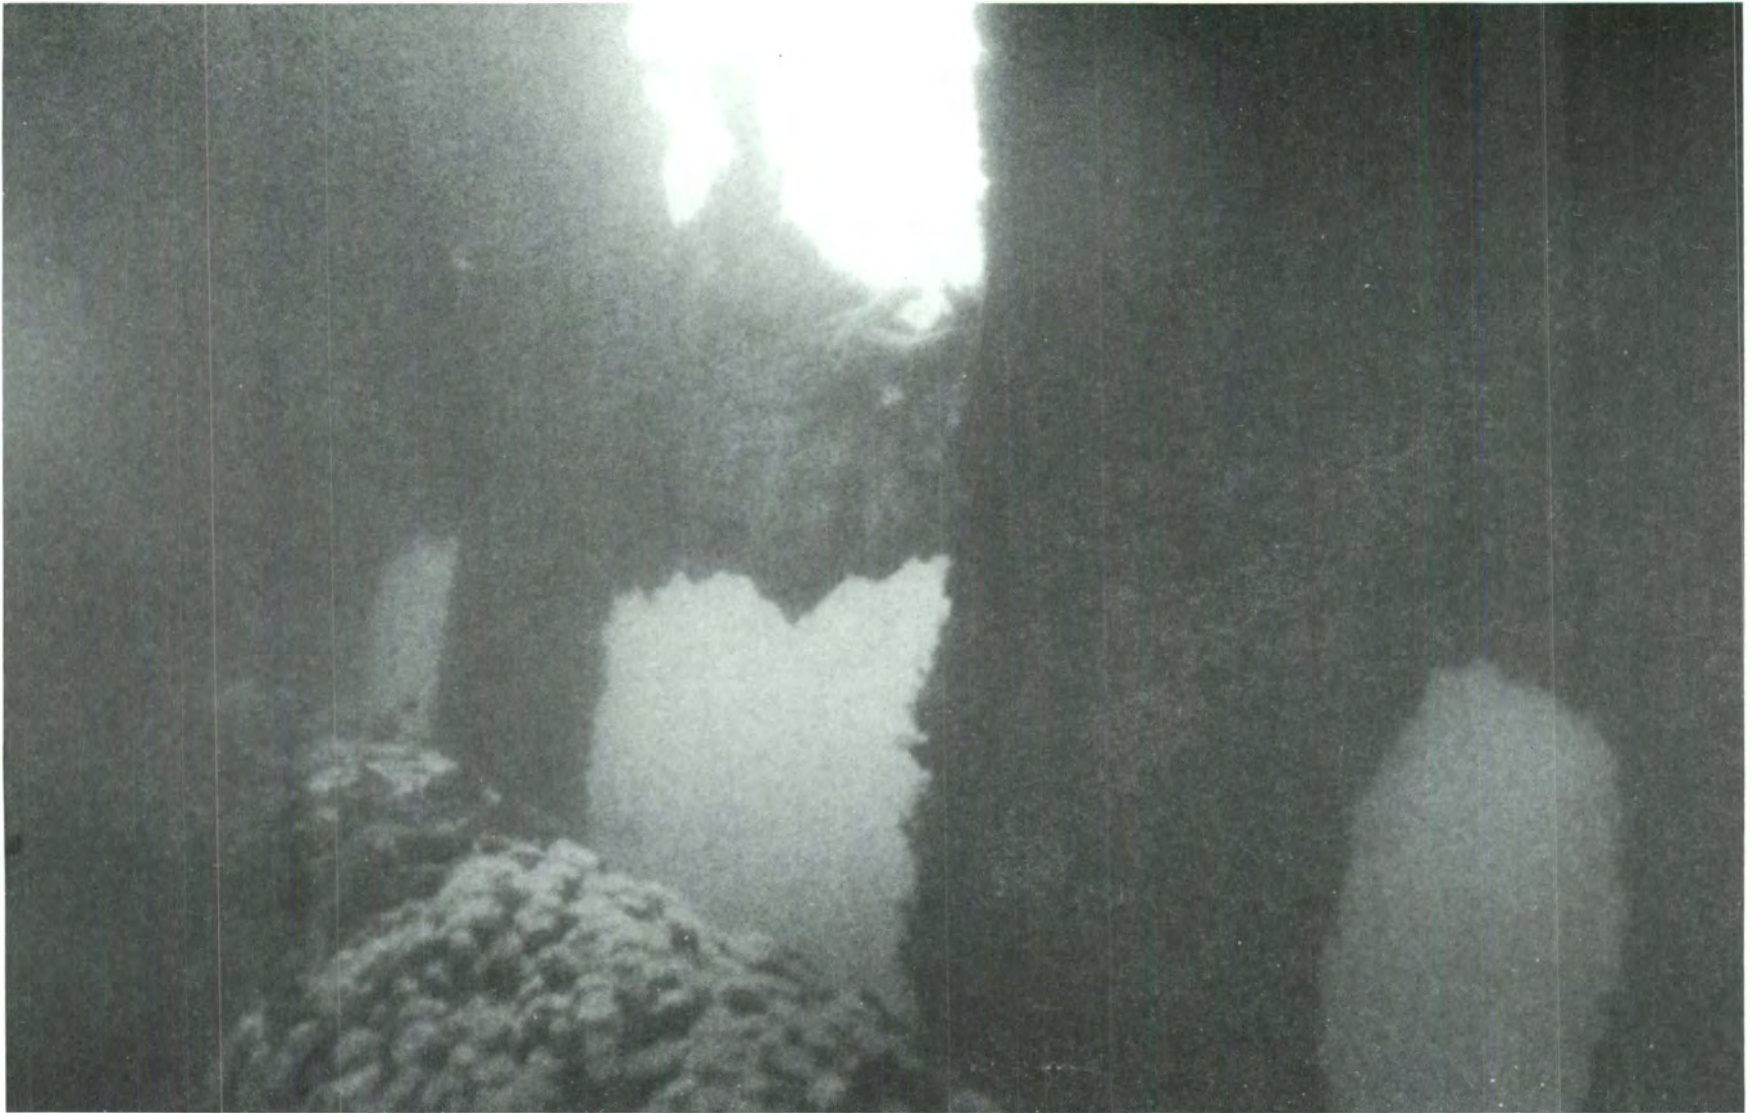
Figure 11. MUNLEON's main shaft and her arched tunnel housing seem to disappear into the turbid water at the vessel's final resting place.

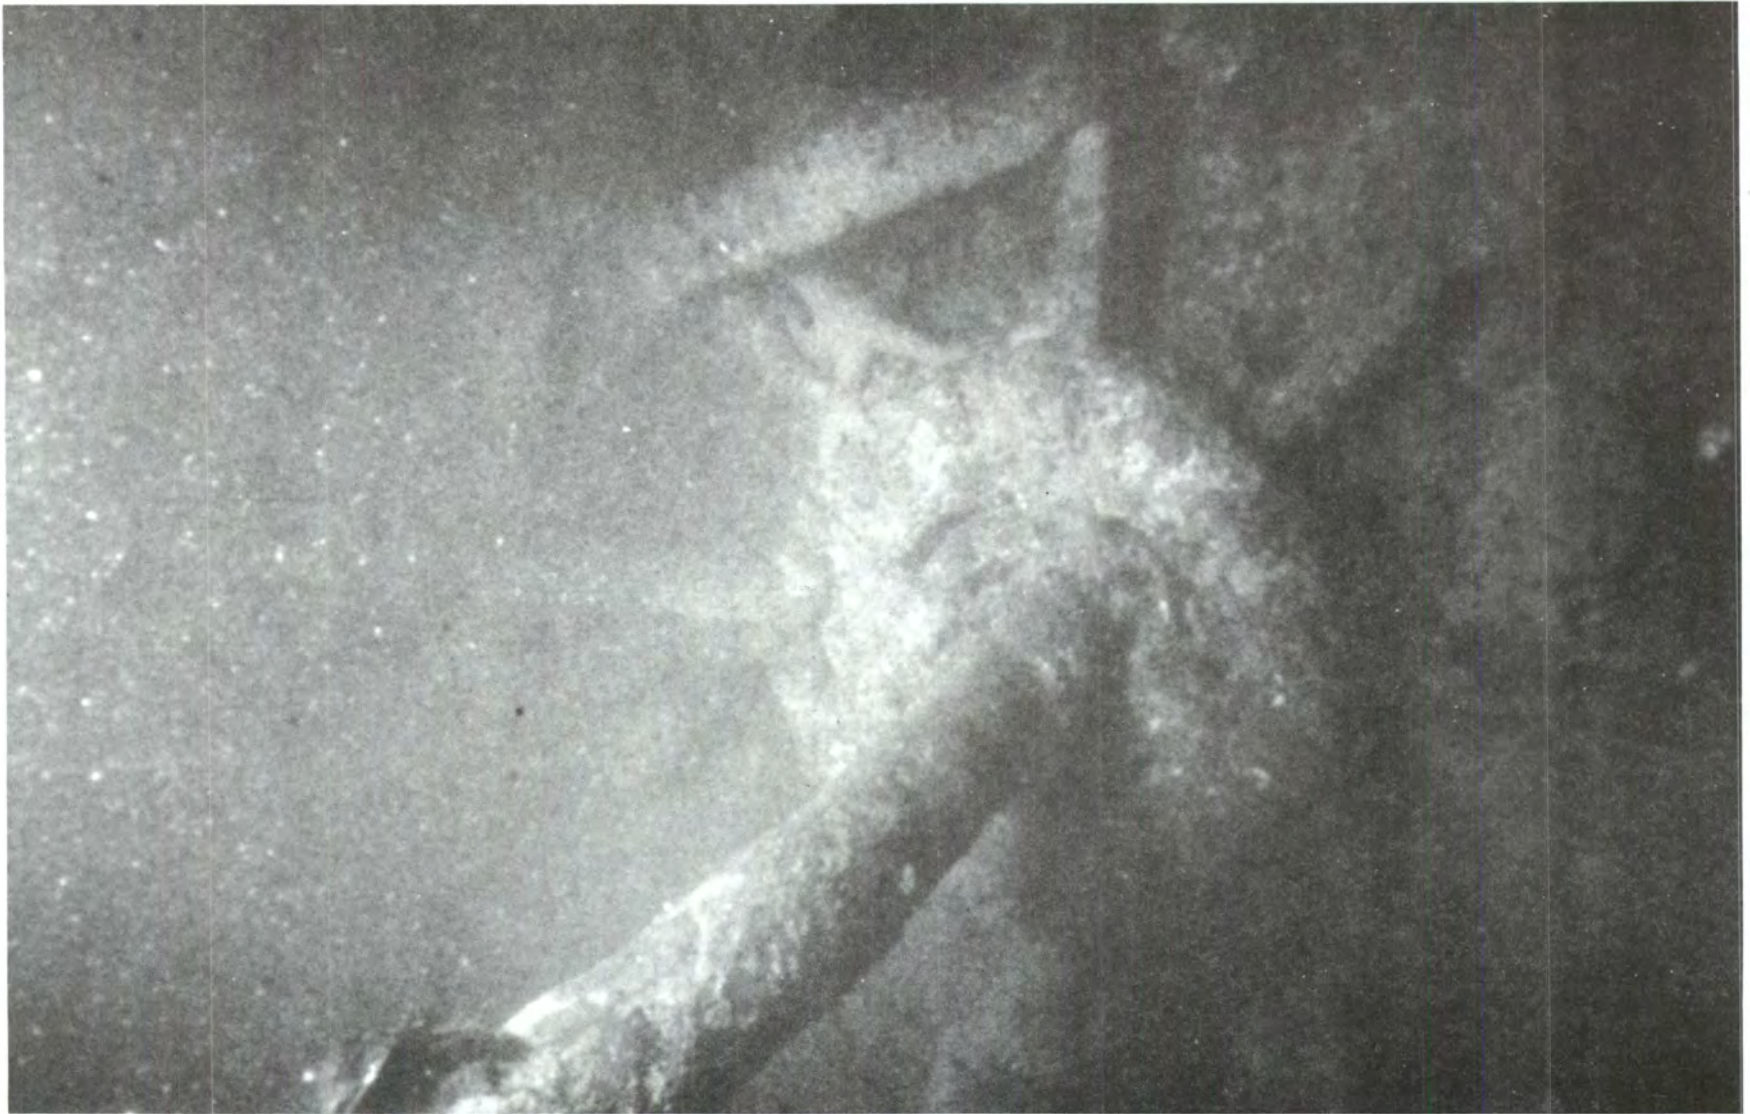
Figure 13. The low pressure cylinder and piston rod of MUNLFON's triple-expansion engine. The engine cylinder head measured 16 feet long and 5 feet high, while the low pressure cylinder was 59 inches in diameter.

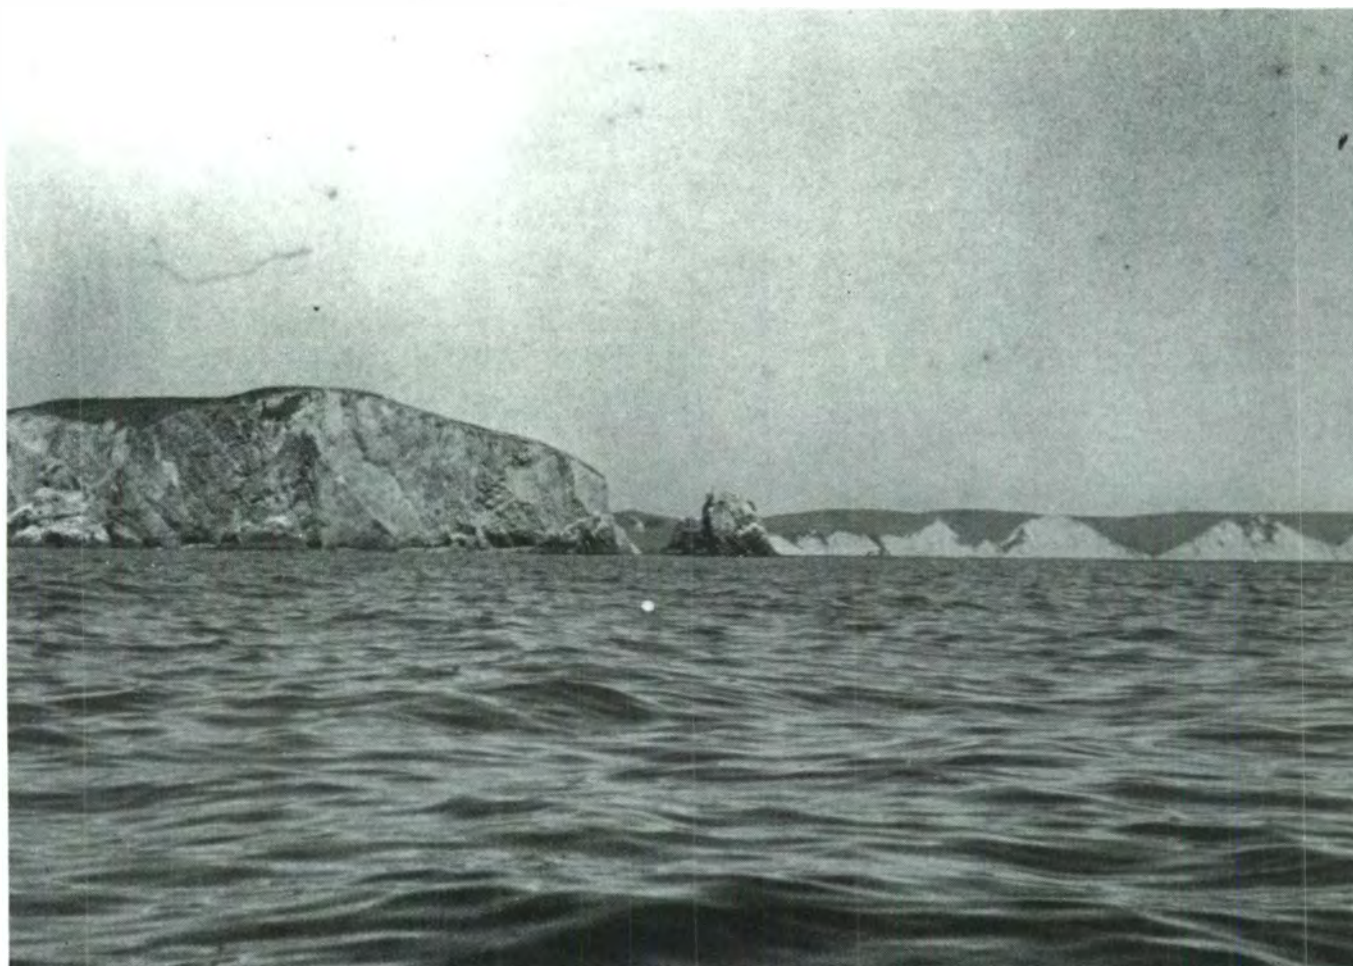
Figure 17. Chimney Rock (center, right) a prominent feature at the tip of the Point Reyes headlands, was used as a guide to the location of RICHFIELD. The vessel sank directly offshore after running aground on a shallow reef. The site, marked here by a buoy, can be relocated by lining up the clump of trees in the center of the notch between Chimney Rock and the headlands bluff.
